SECTION 3

3. WATER RESOURCES

FIGURE 3-3
STREAMS
BUFFALO CREEK WATERSHED

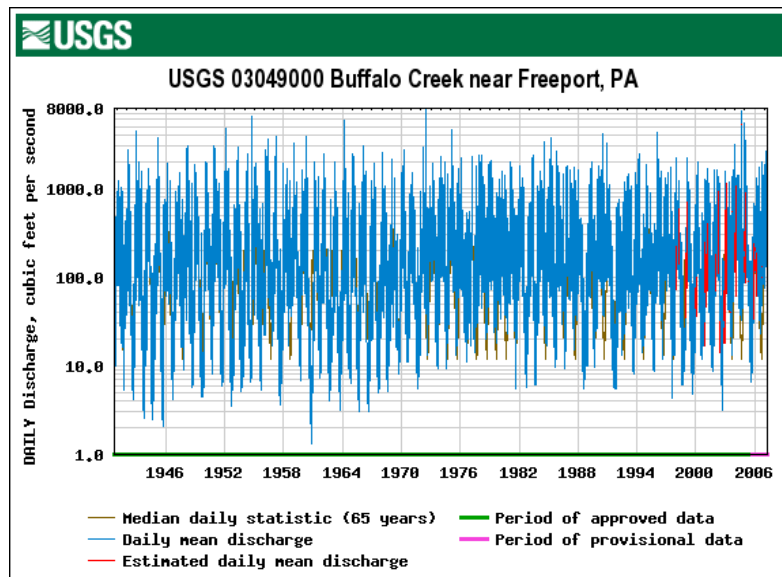
**Figure 3-1
MEAN DISCHARGE**

Most of the precipitation in the watershed falls as rain in the spring and early summer months, however, there is no distinct dry period or significant water deficit incurred during the year. All months receive some precipitation as either rain or snow. The USGS maintains a gauging station on Buffalo Creek in Kepples, Butler County. Between 1941 and 2005, this station recorded an average daily discharge of 195 cubic feet per second (cfs) (Figure 3-1). The highest average daily discharge was 341 cfs in 2004, and the lowest was 121 cfs in 1999. The maximum discharge recorded during this period was 16,700 cfs on September 17, 2004. The lowest recorded discharge was 1,880 cfs on August 15, 1941 (Figure 3-2).

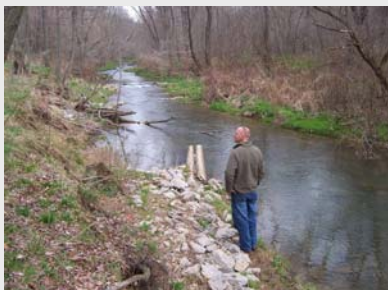
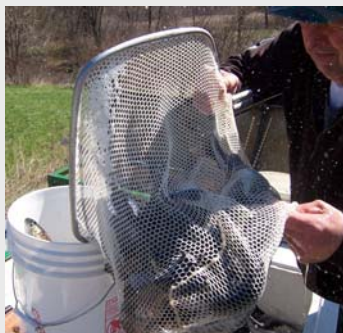
Controlling Streambank Erosion and Creating Fish Habitat

Through the cooperative efforts of the Arrowhead Chapter of Trout Unlimited, PFBC, Buffalo Valley Sportsmen's Club, Armstrong County Conservancy, Snyder Associated Companies, Coors Brewing Company and the Armstrong Conservation District, a number of stream enhancement initiatives to address severe streambank erosion problems and to create fish habitat have been implemented in the upper portions of the watershed.

For example, in the delayed harvest fishing area near Nichola, numerous deflectors and mud sills have been installed on Buffalo Creek at a cost of approaching \$500,000. This area is annually stocked by the Arrowhead Chapter of Trout Unlimited who rear 3,000 to 4,000 fingerlings a year in their Co-op Trout Nursery. The fingerlings are provided by the Pennsylvania Fish and Boat Commission. These efforts have been funded through both federal and state grants.
